IDENTICOM

Technical Bulletin: TB001-1205

SUBJECT:
Cracks in Identicom casing

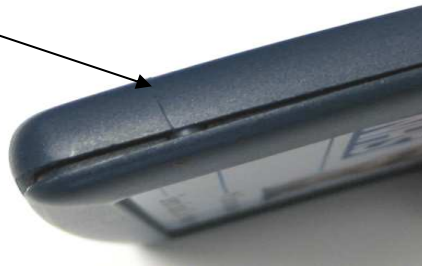
The hairline cracks have been initiated where the front and back plastic components are mechanically joined through a pin.

Crack originating from
mechanical joint

Our investigation has shown that this is an isolated incident caused by a small number of components within a specific production batch of plastic casings being marginally outside the dimensional tolerances set. As a result, increased stresses around the mechanical joint (pin) have initiated the cracks which have spread due to the loads placed on the casing during normal use.

Although our investigations have shown this to be a problem that will only affect a minute percentage of units, Connexion2 has implemented modifications to the injection moulding process and introduced additional quality control steps to ensure the elimination of this problem.

Should any user of the Identicom therefore discover such hairline cracks in the plastic casing of their Identicom unit that has not been induced by any kind of mishandling of the unit then we will replace the plastic case of the unit in question. Please follow the normal Connexion2 returns procedure to effect this change.
