IDENTICOM

Technical Bulletin: TB002-0206

SUBJECT: **Varta battery failure**

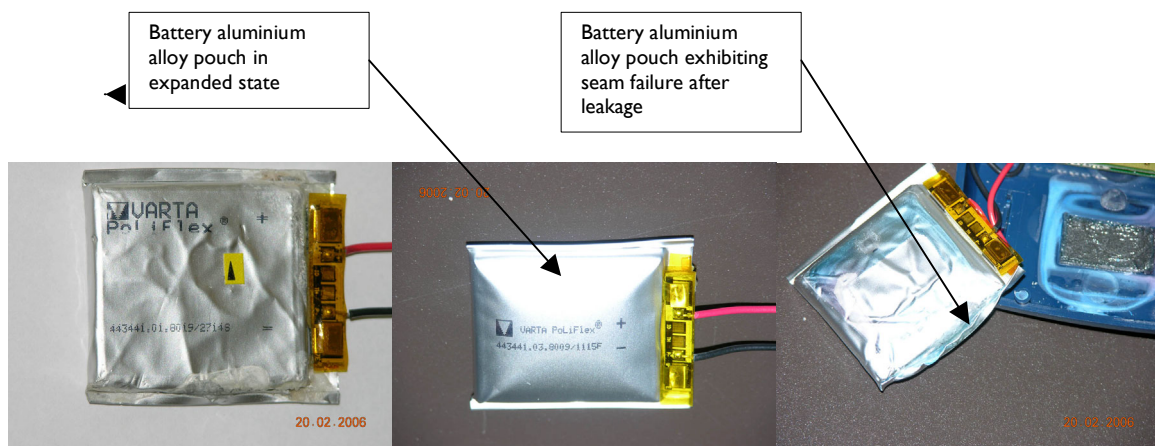
Corrosion in the Lithium Polymer battery package causes a reaction which results in the battery package failing, swelling or leaking. The cause of the issue is a failure in the composition of the battery pouch material which is formed from a composite, multi-layered, laminated foil of aluminium alloy and special plastic films.

Varta state that their suppliers foil was substandard in this batch and occasionally 'fissures' may appear. These fissures in the material would allow the chemicals within the battery to make contact with the alloy and therefore corrosion developed slowly, aggravated by the electrolytic action within the cell.

Varta have accepted full responsibility for this issue and have quarantined all batch stock affected. Stock of batteries remaining in Connexion2 manufacturing have also been quarantined and are in the process of being swapped out for new, unaffected stock.

Varta have assured us that all new battery manufacture will incorporate aluminium pouch material free of defects.
